SPOFFORD LAKE DAM

NH 00356

PHASE I INSPECTION REPORT
NATIONAL DAM INSPECTION PROGRAM

NOVEMBER 1978

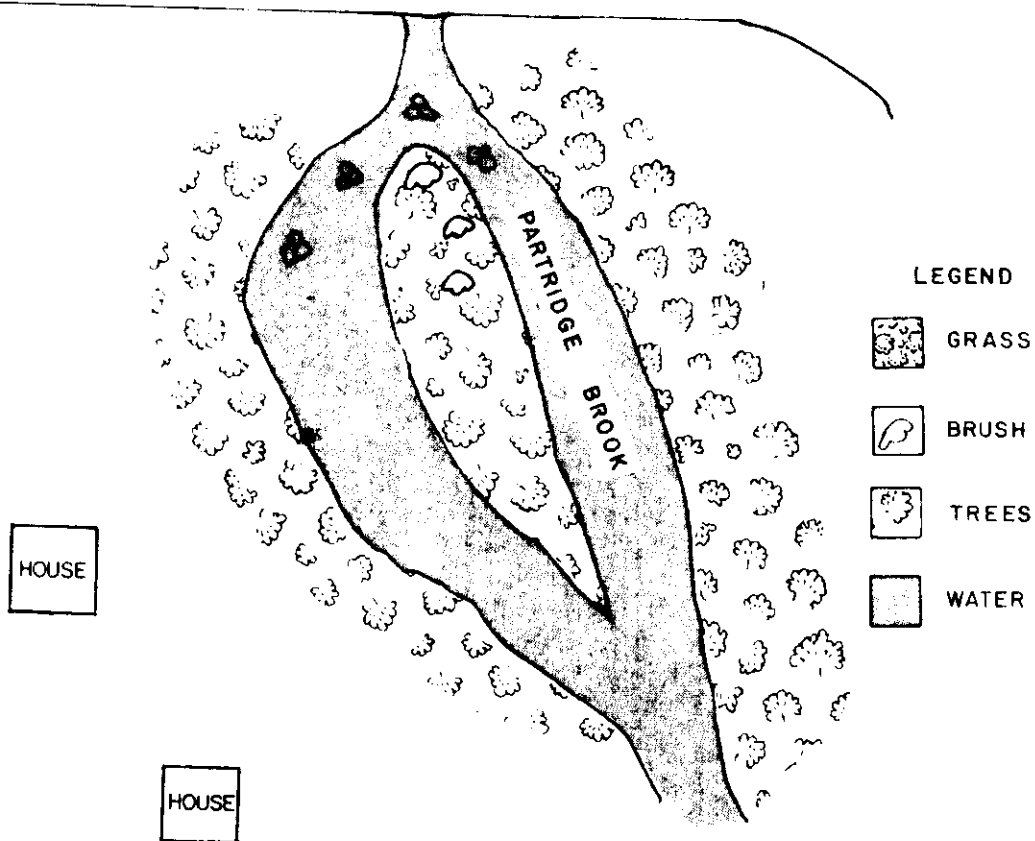
FIG. 1
SITE PLAN

Spofford Lake Dam lies on Partridge Brook in the village of Spofford, NH. Canal Street runs directly over the dam and the site is easily reached via Routes 9 and 9A. The portion of the USGS Keene, NH quadrangle presented on page viii shows this locus. Figure 1 of Appendix B presents a site plan developed from historical records and the site visit.

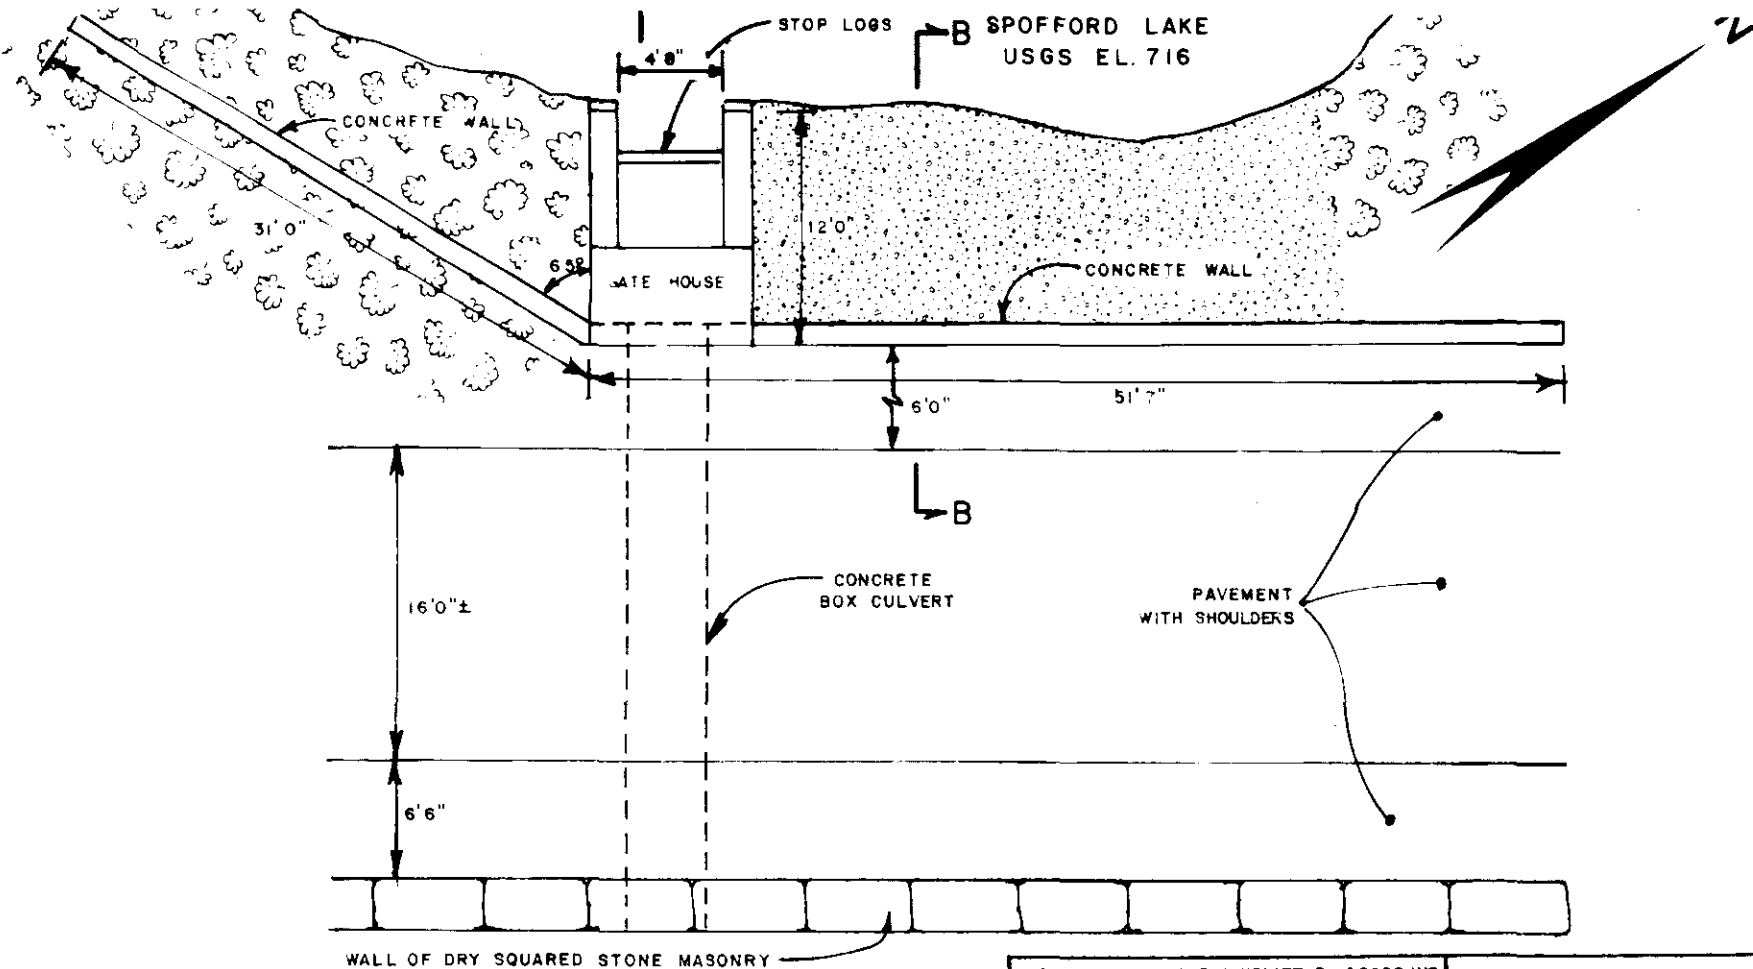
FIG. 2

The dam is basically an 83 foot long earth-filled masonry crib with a concrete wall serving as the upstream face and a squared stone masonry wall forming the downstream face (Figures 2, 4 and 5). A considerable quantity of loose gravel has been dumped in front of the upstream wall (Figure 5). The dam is approximately 28 feet wide and has a maximum height of almost 11 feet (Figure 4). Discharge at the dam is through a concrete culvert which is 4 feet wide by 3 feet 9 inches high at the upstream concrete wall and which decrease slightly in size as it passes under Canal Street. A steel sluice gate, still in place, but badly deteriorated, once controlled flow into the culvert. A 4 foot 9 inch wide stoplog weir, installed on the recommendation of the New Hampshire Water Resources Board in 1955, now performs this function. The dam has no functional spillway in its present configuration.

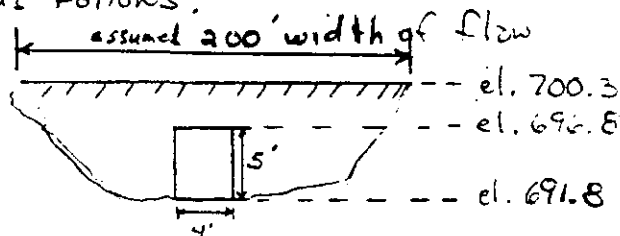
An iterative process is used to converge on the flood level in the reach. The roadway and culvert are as follows:

- ① Using the FHWA nomographs for roadway culverts and assuming the water level is at the roadway crest:

~~and~~ depth to height ratio = $\frac{700.3 - 691.8}{5} = 1.70$

so the depth of flow in Reach 2
is 1.4 ft. over the roadway.

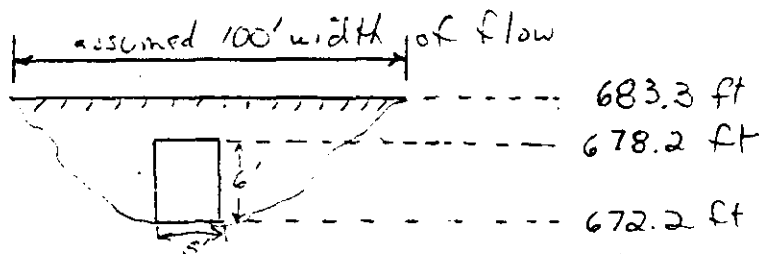
Reach 3: Using the same iterative process as was used in reach 2 with the roadway and culvert as follows:

- ① Assume the water level is at the roadway crest (el 683.3)

$$\text{depth to height ratio} = \frac{683.3 - 672.2}{6} = 1.85$$
